Manhole Inspection Summary

Manhole # S61K__012MH

Insp Date: **3/18/08 12:42 PM**

Location Address: **701 Tolna St.**

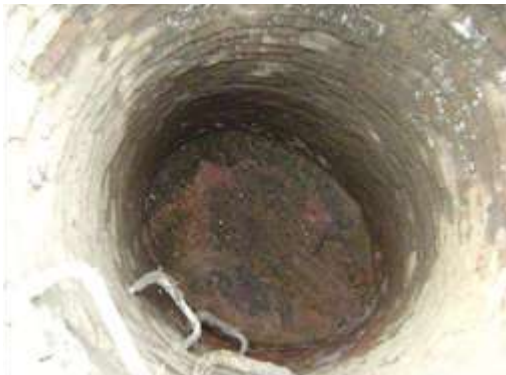
Defect 2

Infiltration from bottom of corbel to bottom of barrel

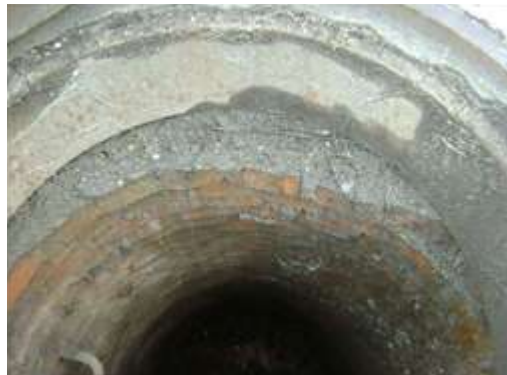
Defect 3

Infiltration at chimney joint

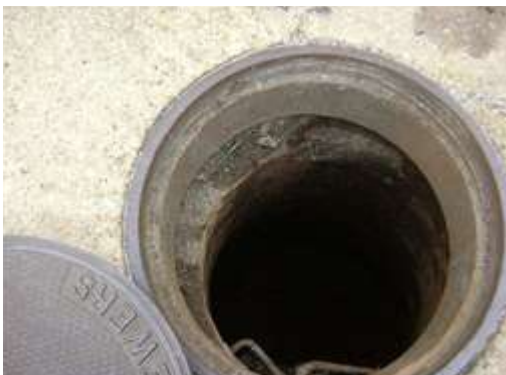
Defect 1

Offset: **3** (in.)

3" Frame Offset

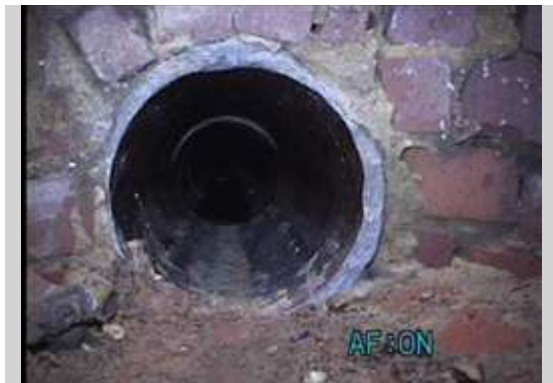
12 O'Clock Outflow

8 in. Circular Gravity Sewer
Pipe Out @ 12 O'Clock

Pipe Height: **8.4** (in.) Rod and Bar (Angled)

Pipe Material: **Clay** ☐ Pipe Lined

Invert Depth: **8.92** (ft.) Flow Characteristics: **None**

Infiltration: **None** Pipe Seal Cond: **Sound**
